#### **CASE STUDY**

The case study involves an existing four storey apartment building which comprised of concrete columns, wall panels and proprietary prestressed floor beams and Hollowcore floor planks— all of which were precast elements fabricated offsite.

A car fire on the ground floor carpark had resulted in several of the first floor Hollowcore planks becoming structurally compromised beyond repair.

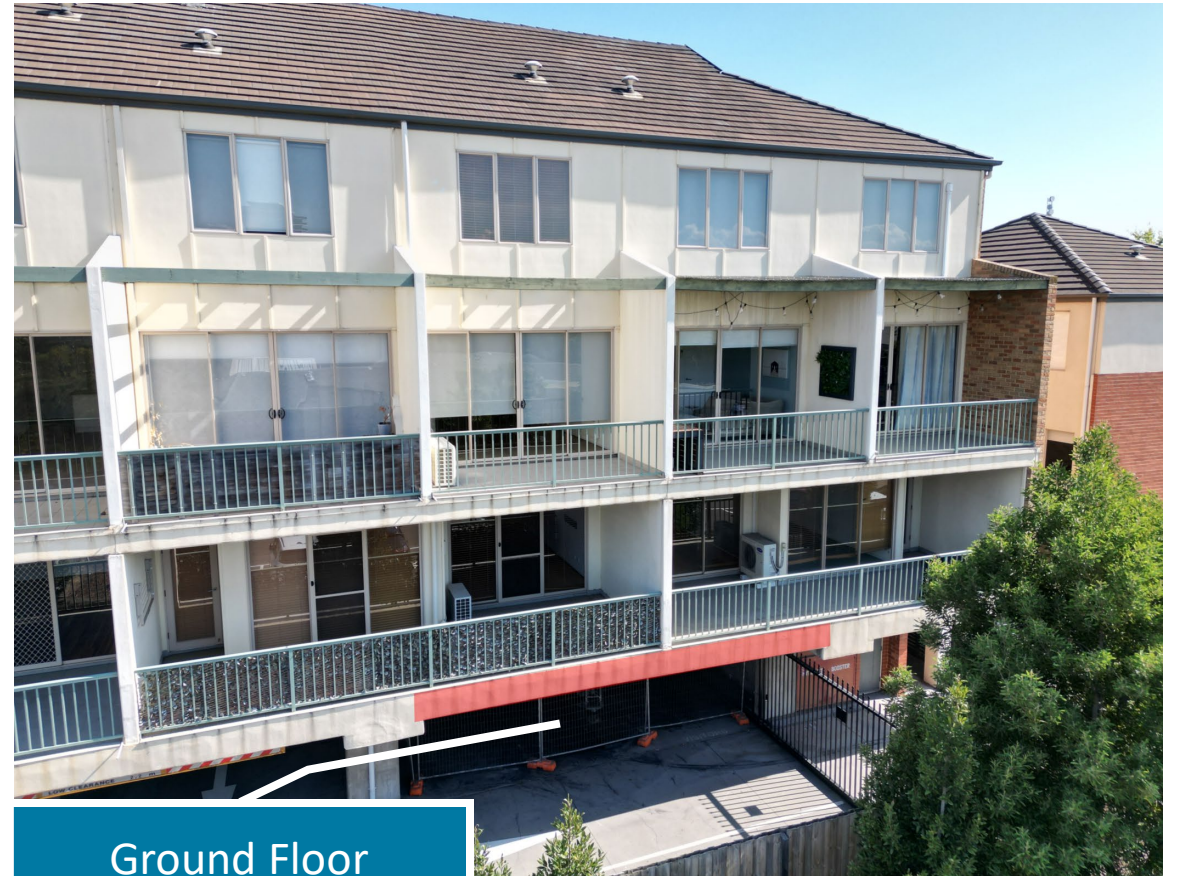
A car fire on the ground floor carpark had resulted in several of the first-floor Hollowcore planks becoming structurally compromised beyond repair.

Ground Floor  
Car Fire

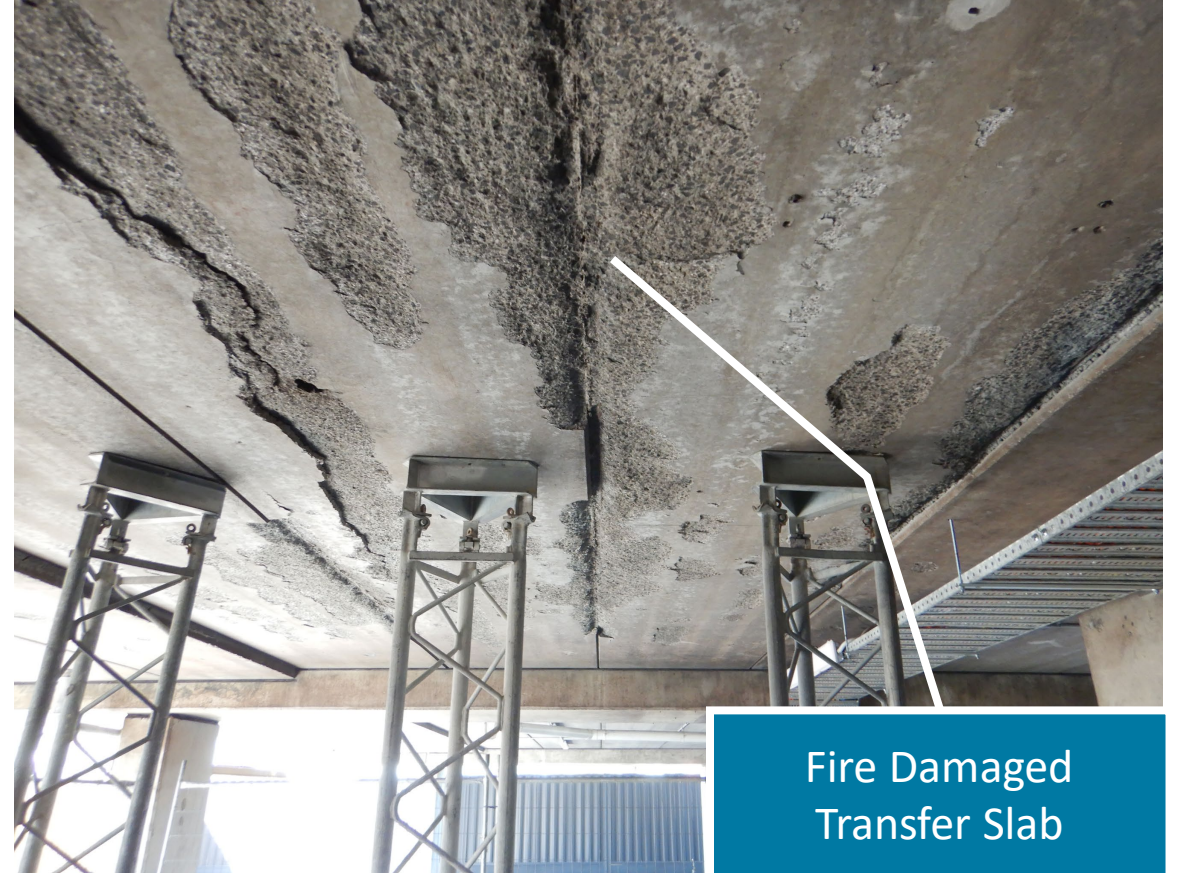
The damaged Hollowcore planks were critical structural elements which supported the levels directly above.

The damaged Hollowcore planks were not able to be replaced like-for-like due to constructability issues.

Specifically, the crane would not be able to install new precast Hollowcore planks from above without first demolishing the upper levels of the building.

Fire Damaged  
Transfer Slab

Imparta Engineers initially attended the site to undertake concrete testing using a Schmidt Hammer to determine the severity of the damage.

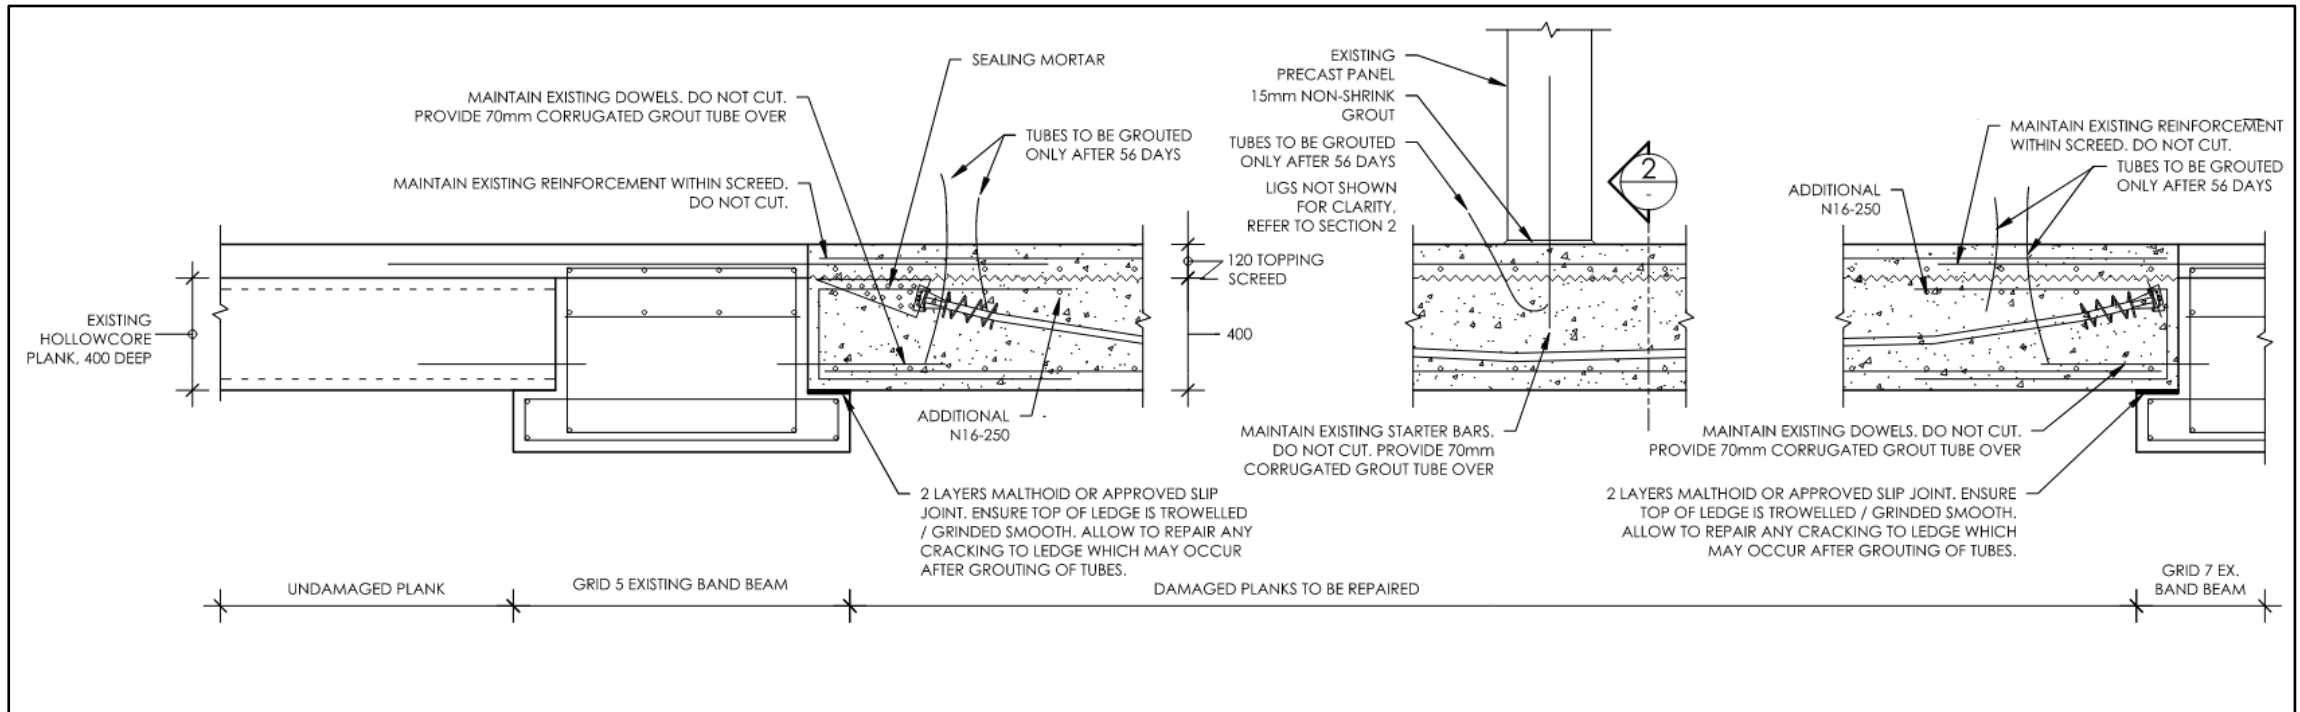
SECTION DETAIL OF NEW TRANSFER SLAB

Pouring a new in-situ new post-tensioned floor slab, leaving pockets in the slab for the vertical propping supporting the precast panel.

Pouring a new screed layer to tie the new slab into the existing starter bars once stressing of the new floor slab had been completed.

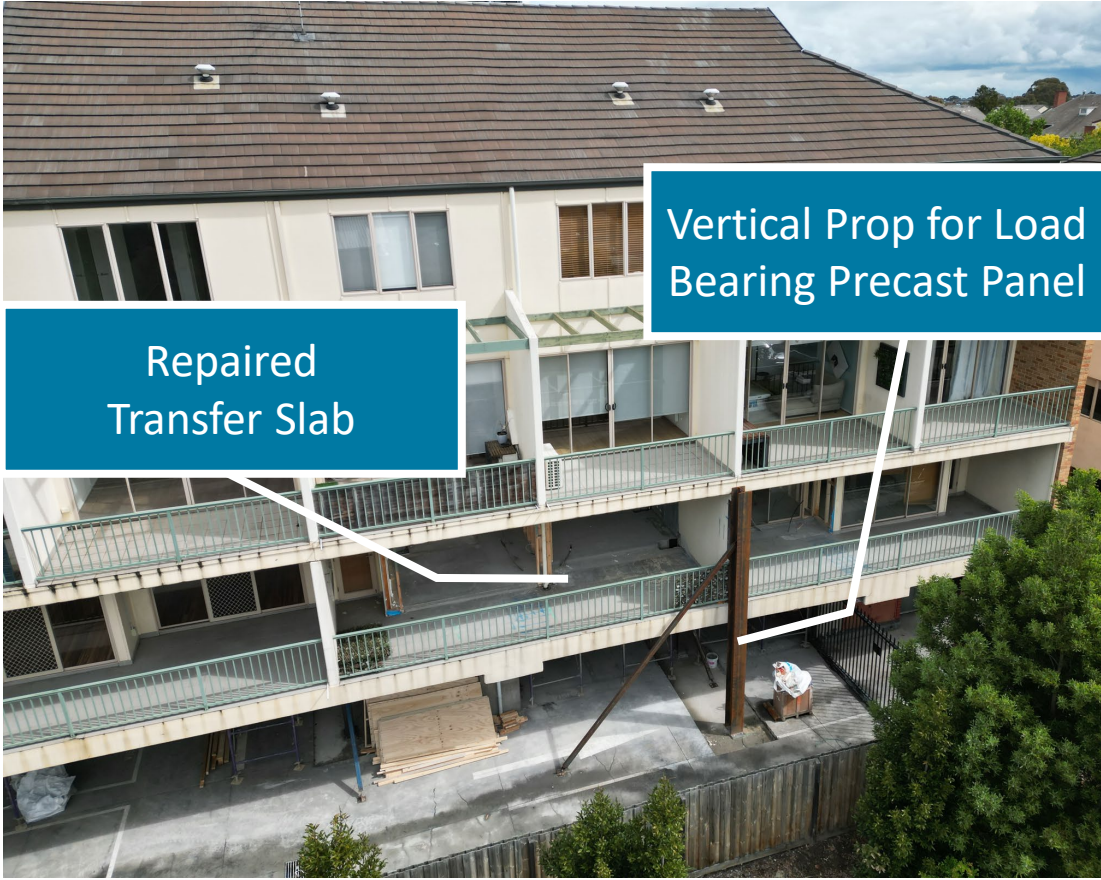
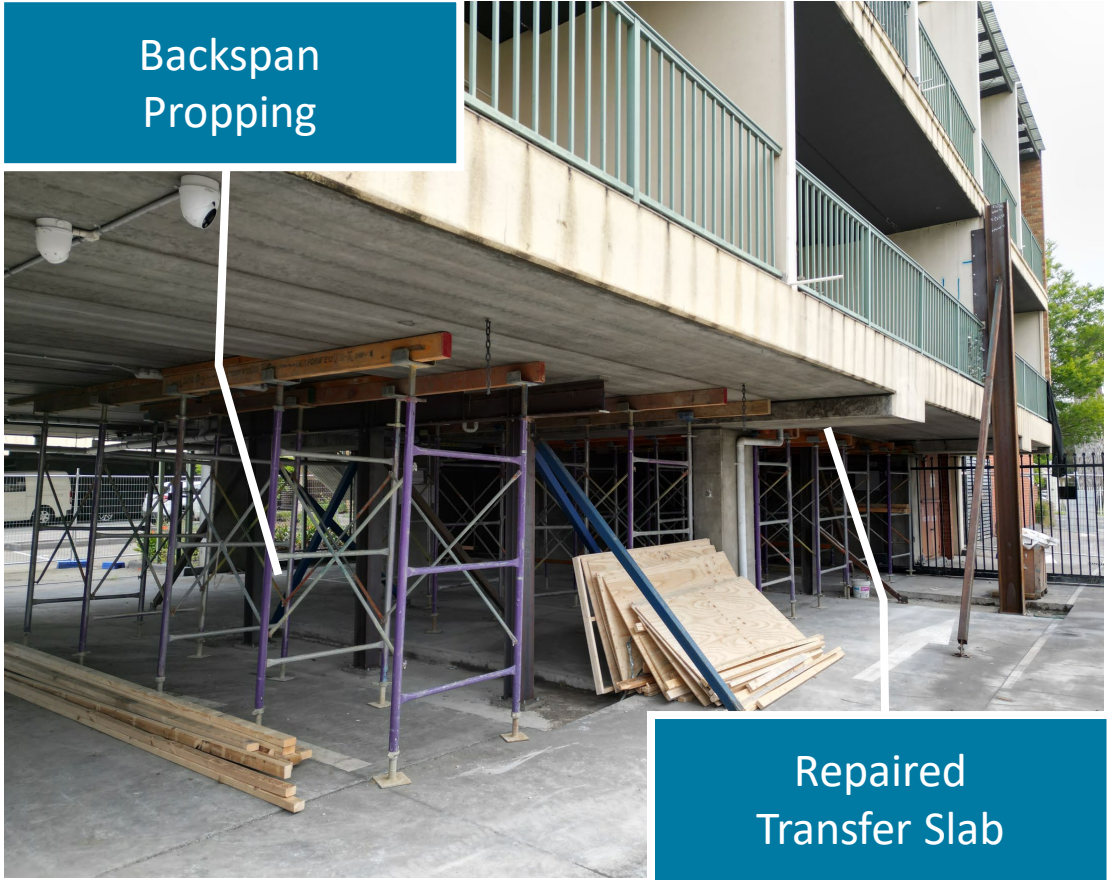
REPAIRED TRANSFER SLAB (WITH PROPPING IN PLACE)

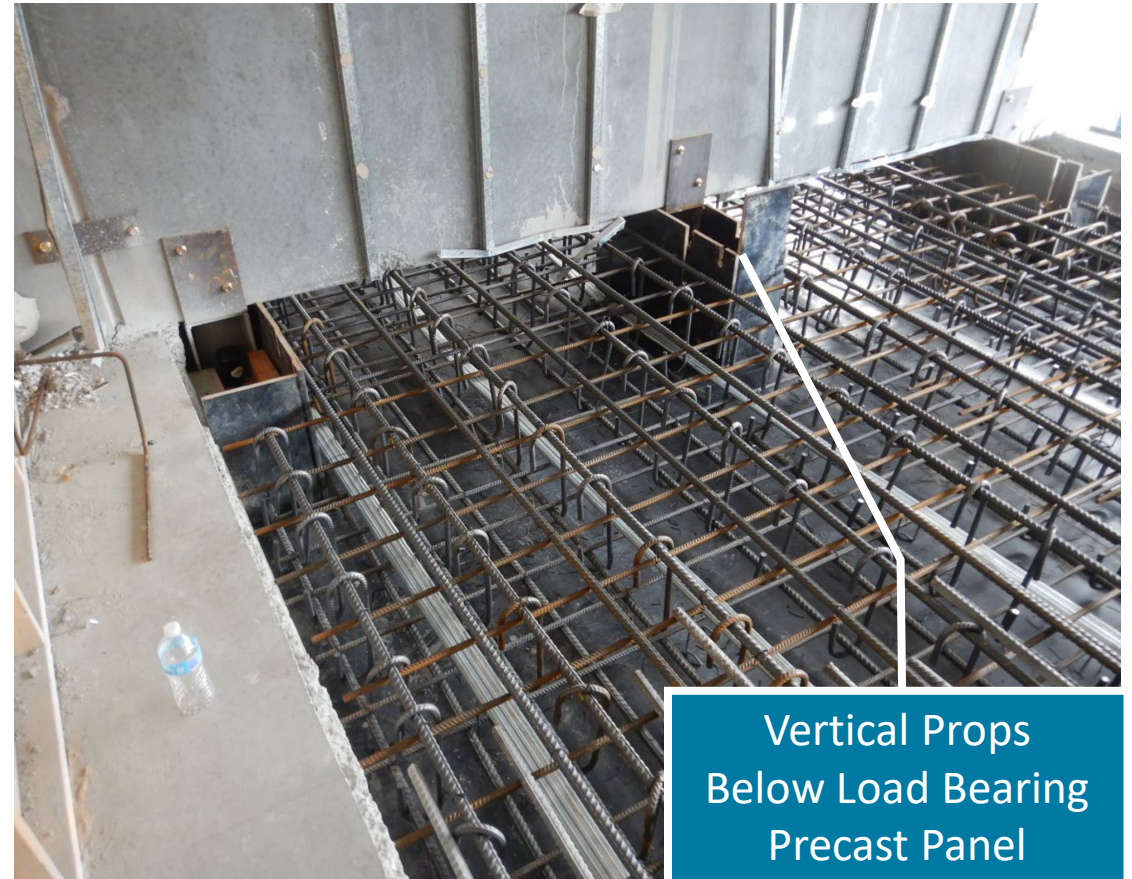
**Vertical Props  
Below Load Bearing  
Precast Panel**

Carefully punching through the existing damaged Hollowcore planks to prop and brace the load-bearing precast panel above, while avoiding damaging the existing prestressing strands.

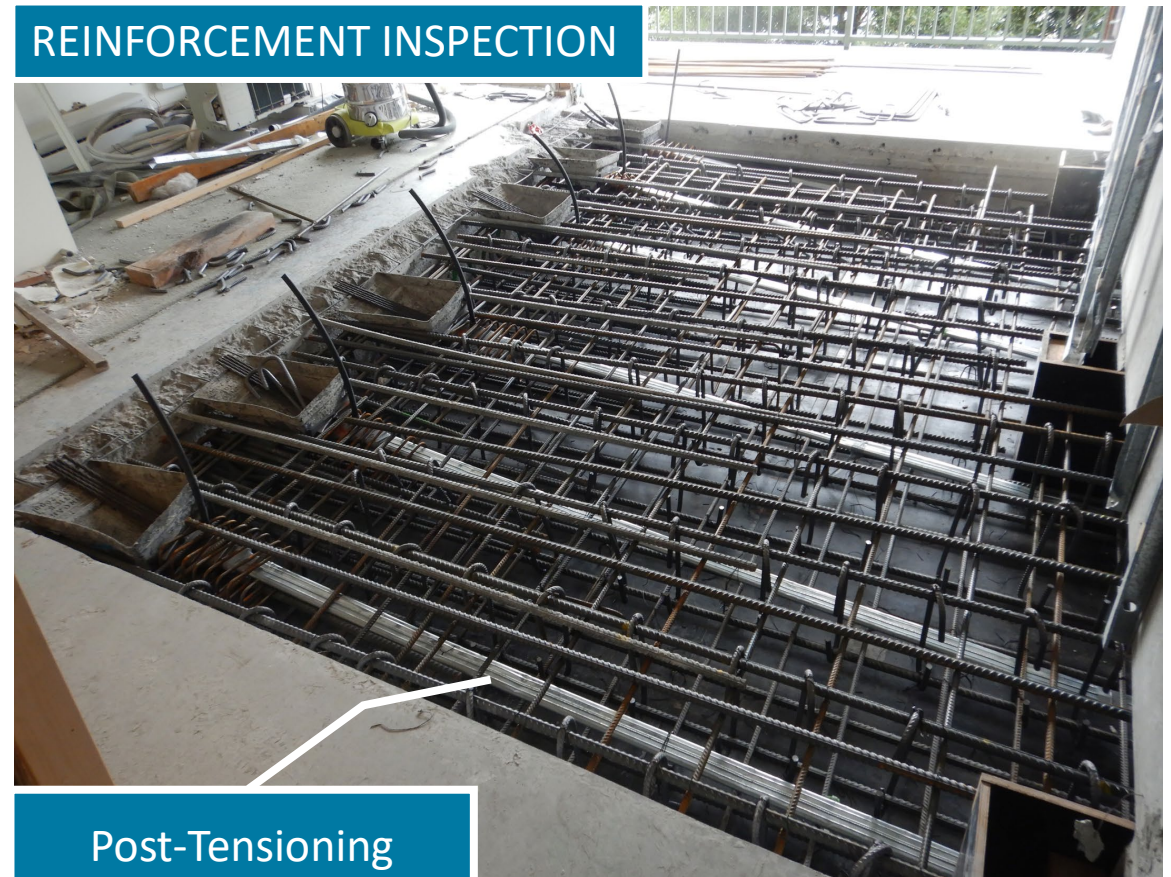
REINFORCEMENT INSPECTION

Post-Tensioning  
Tendons

Imparta Engineers undertook inspections at all critical stages, including inspection of the temporary propping, footing reinforcement, and slab reinforcement, to ensure that the construction was in accordance with the design documentation.
